What have we learnt during Remix project?

*Michalina Makowska, M. Sc.
Aalto University, Department of Civil Engineering*

Hot In-place recycling

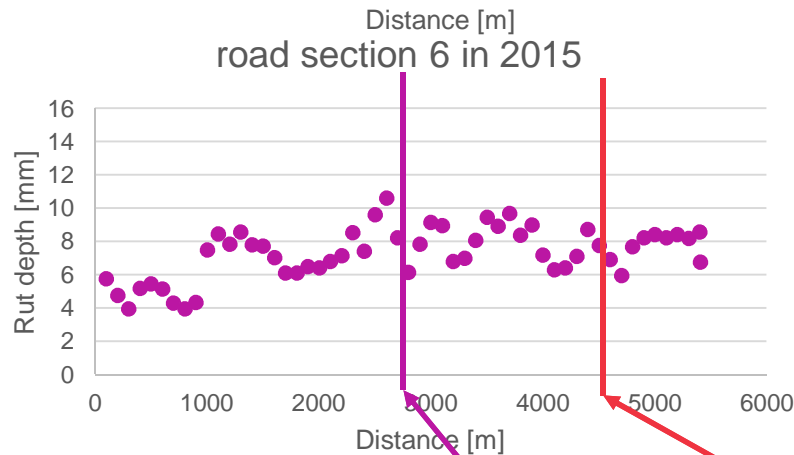
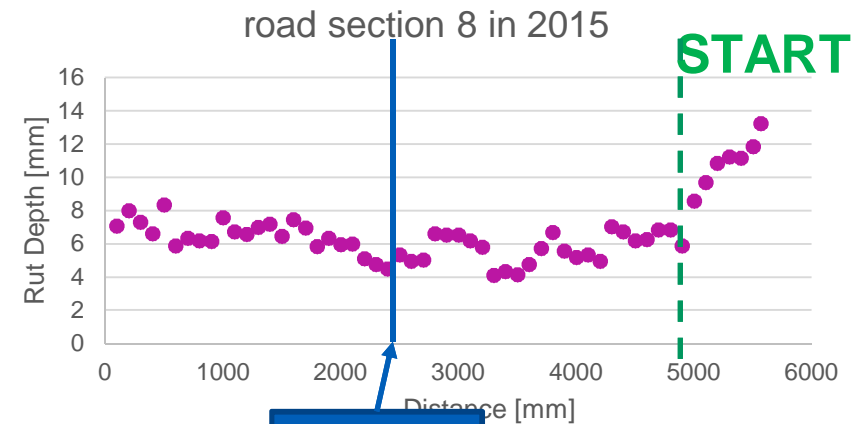
The rut depth is highly variable after REM'13, but...

Some sections improved in homogeneity

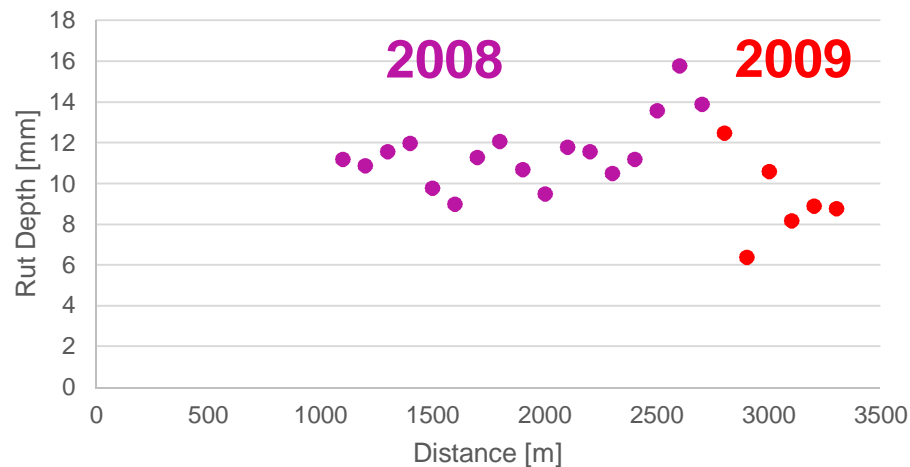
road section 4 - before

Traffic rearrangements due to
neighboring construction site

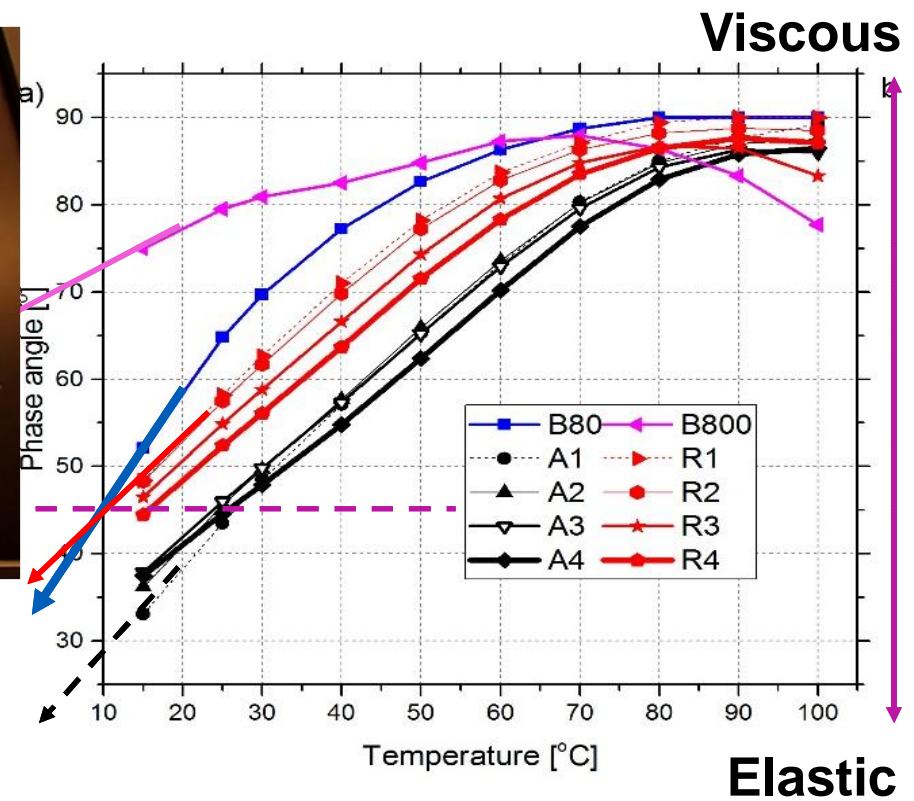
The phase angle did not recover completely

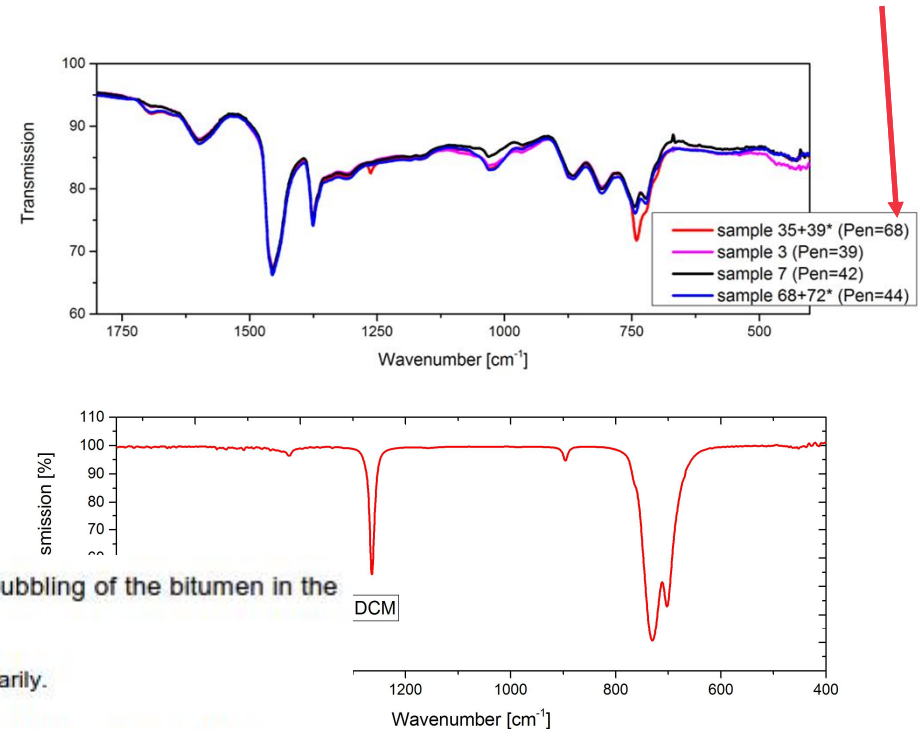
Bitumen extraction – presence of solvent à softening

DCM peaks are visible in extracted bitumens
